# Restoration of Liberty Island and side- branch

WWF Hungary  
Tamas Gruber, freshwater programme  
manager

Danube,  
downstream  
Gemenc,  
close to the  
Cro-Hu  
border

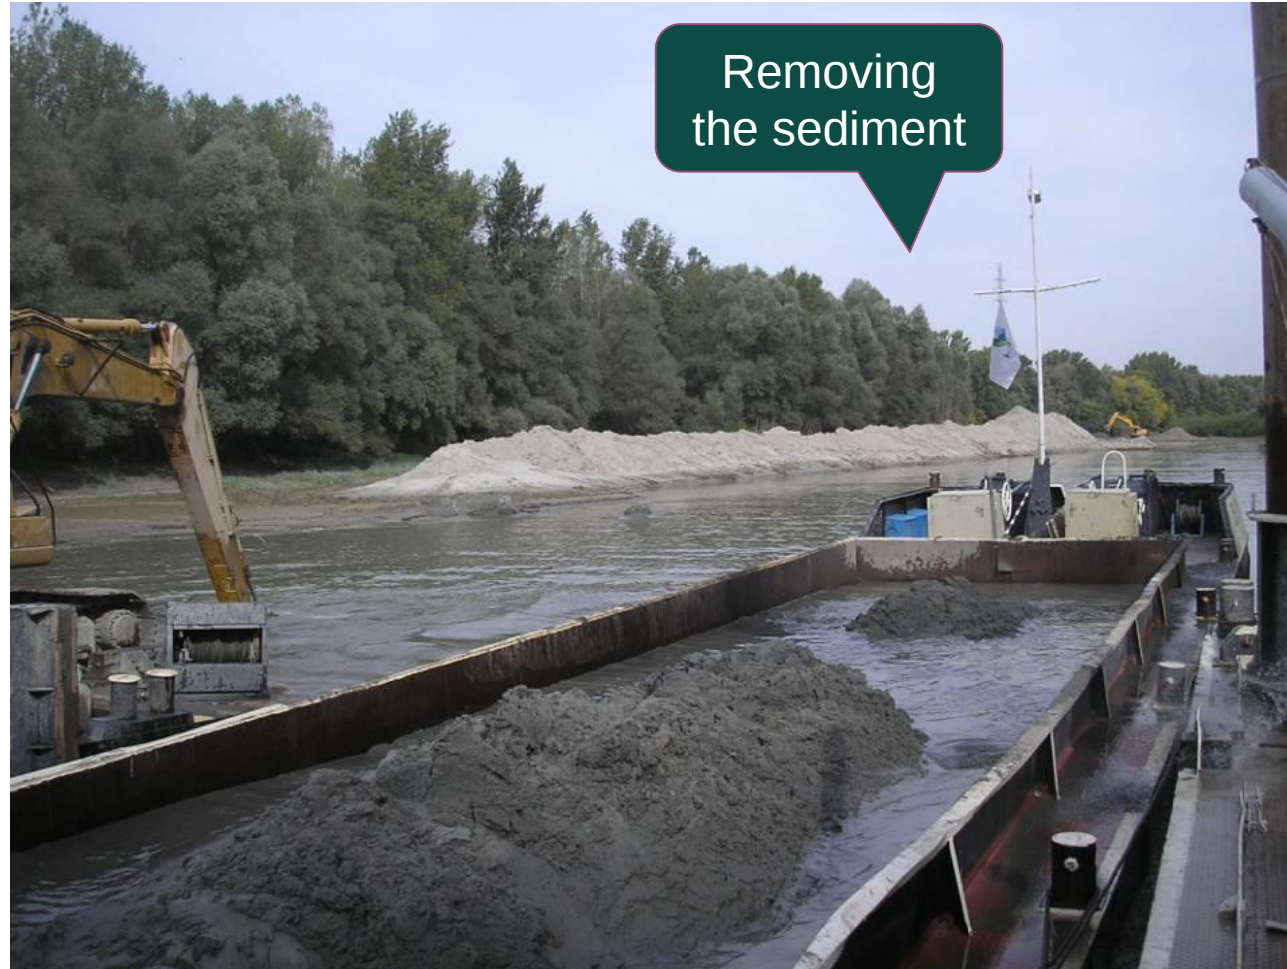
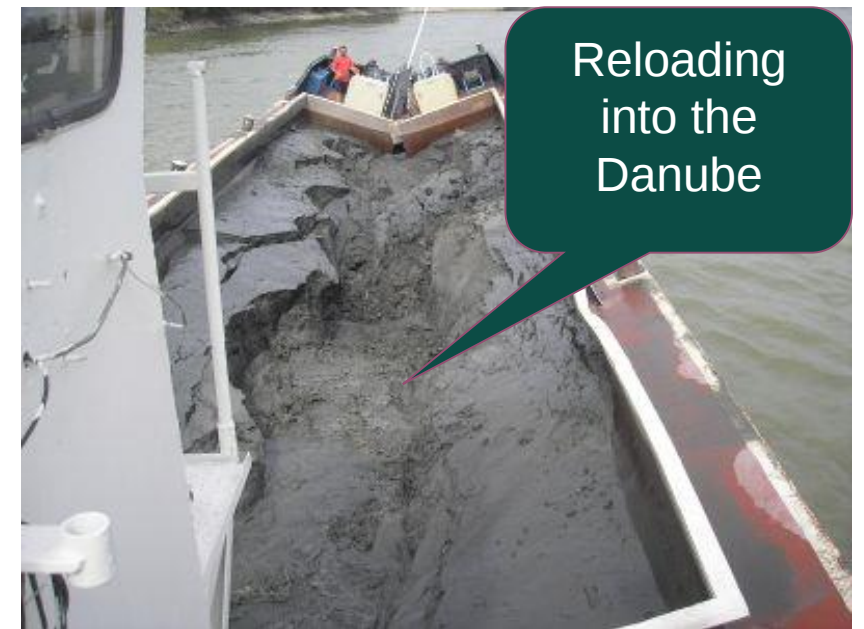
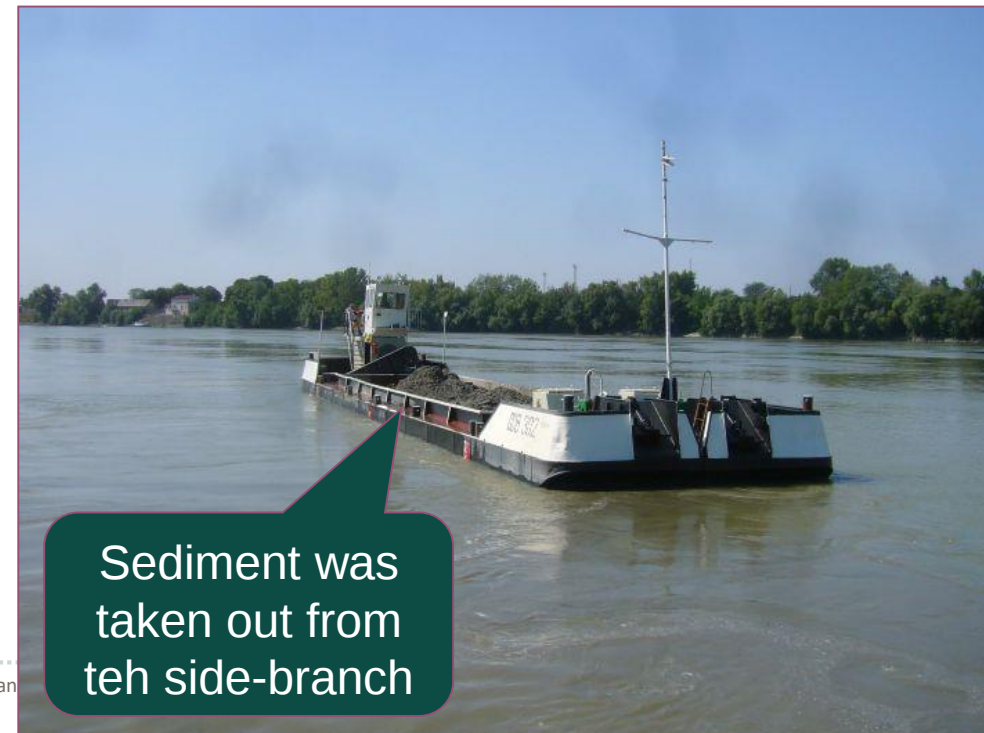
This was the largest scale ecological dredging along the Hu Danube

- Dredging: 160 thousand cubic metre
- Waterpipe relocation, 2 pipes of D700 mm + 1 pipe D160 mm, appr. 200 m length each
- Opening the rockfill dam: 3000 cubic metre stone
- Forest conversion: 9 ha native, semi-natural forest
- Forestry works: two seasons for planting and 3 years for nursery

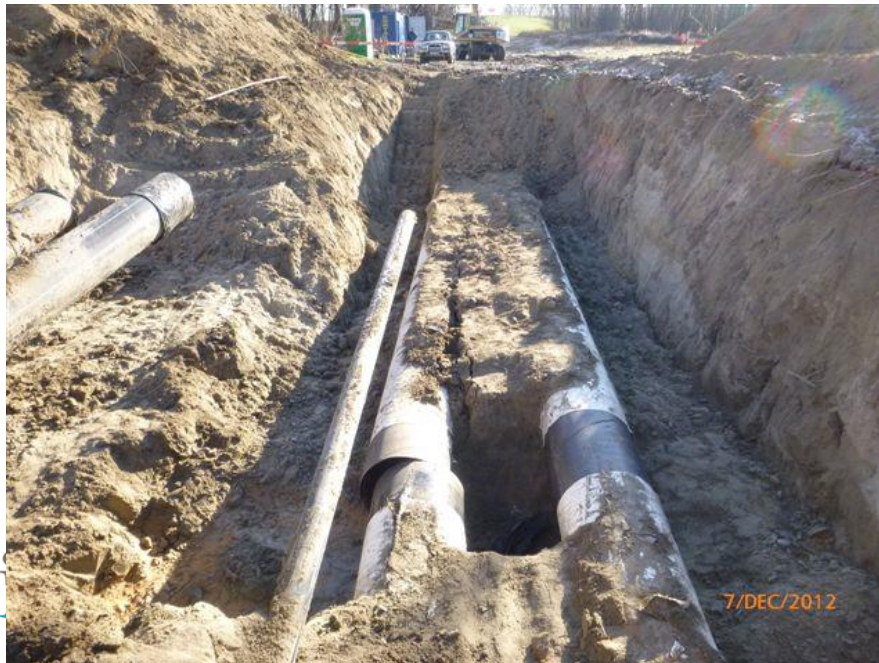
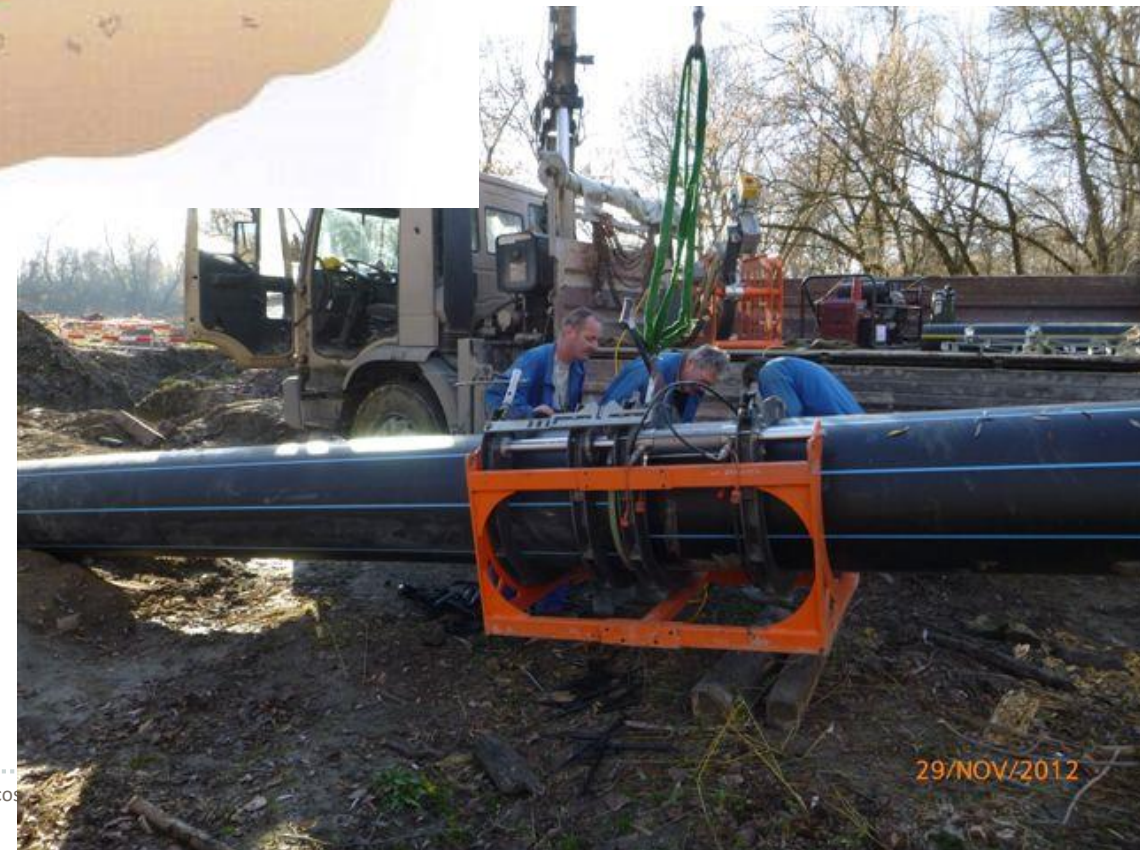
Special technical solutions – drinking water tubes were relocated,  
From the rockfill dam > > under the side-branch

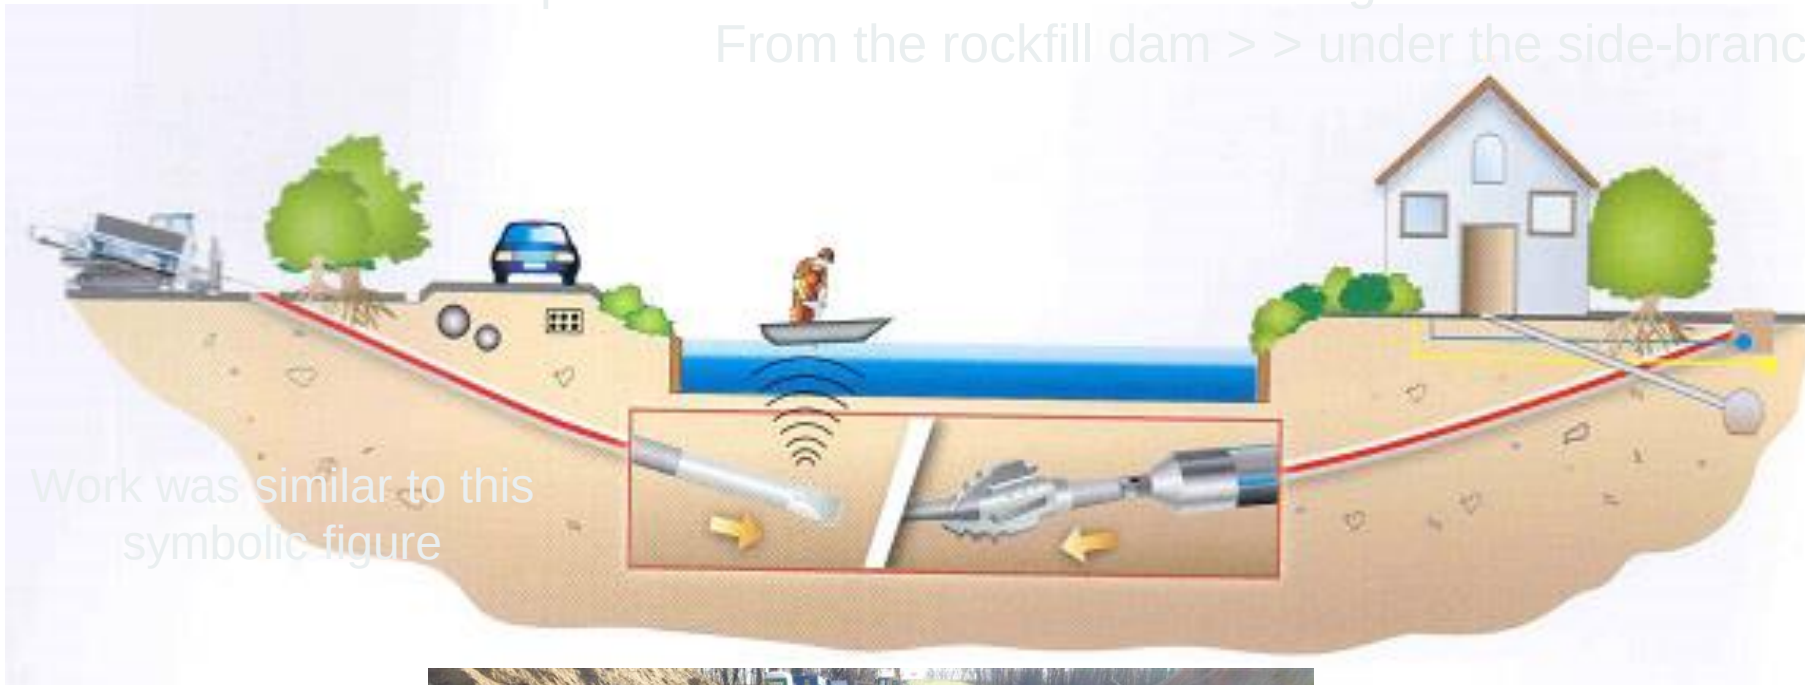
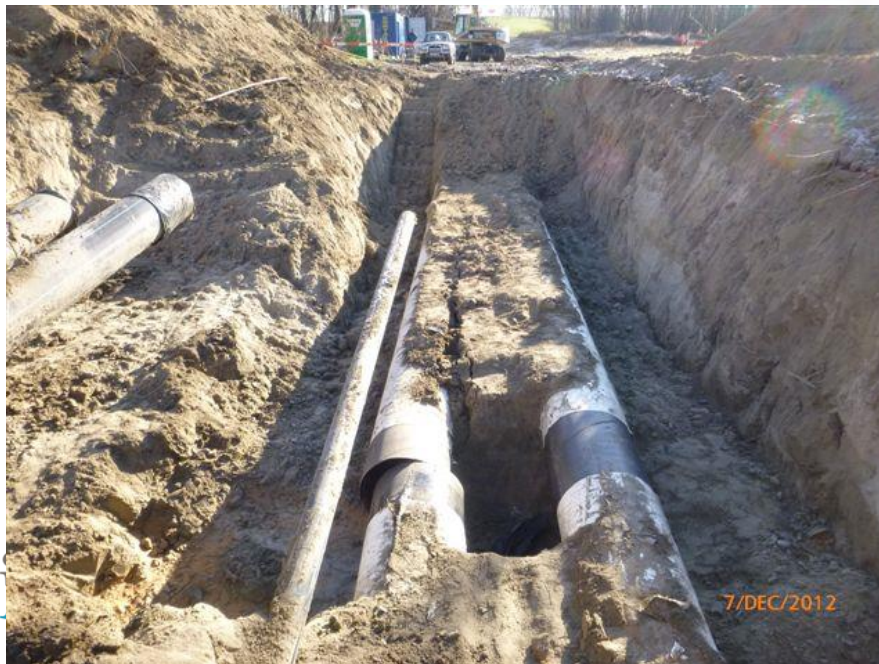
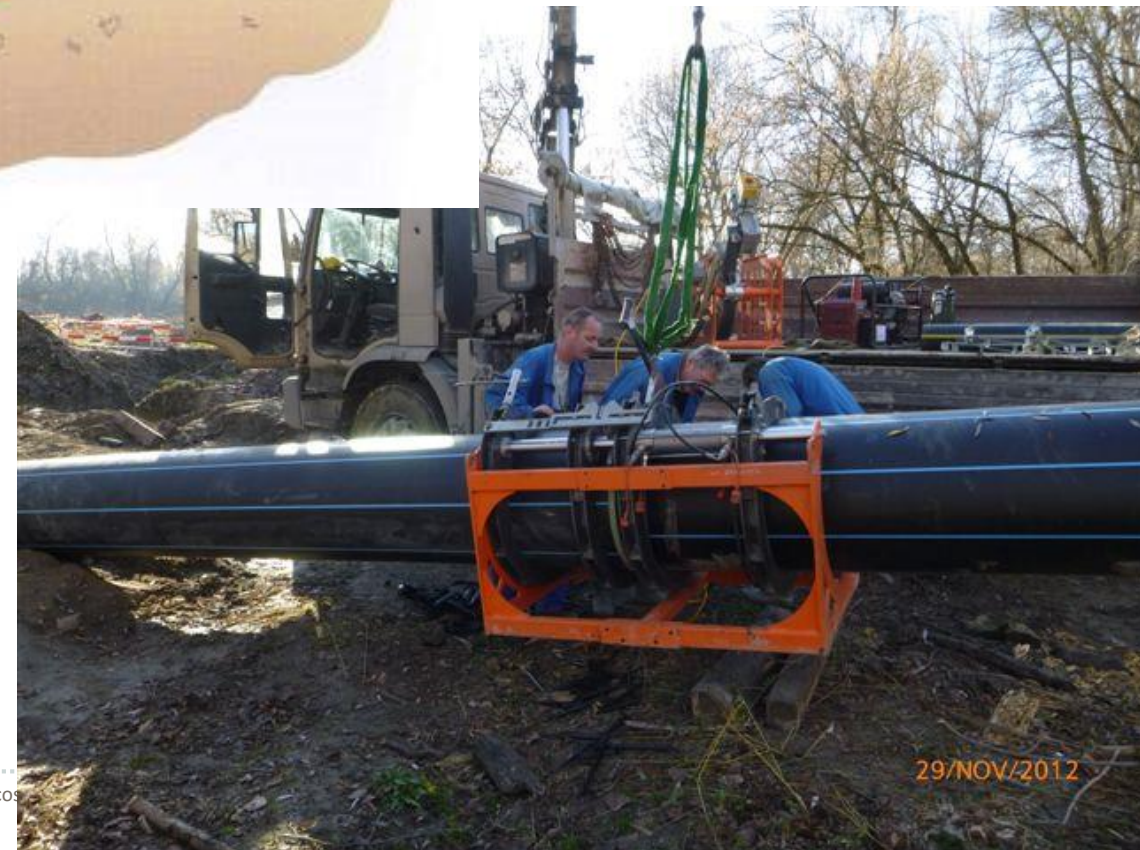
Special technical solutions – drinking water tubes were relocated,  
From the rockfill dam > > under the side-branch

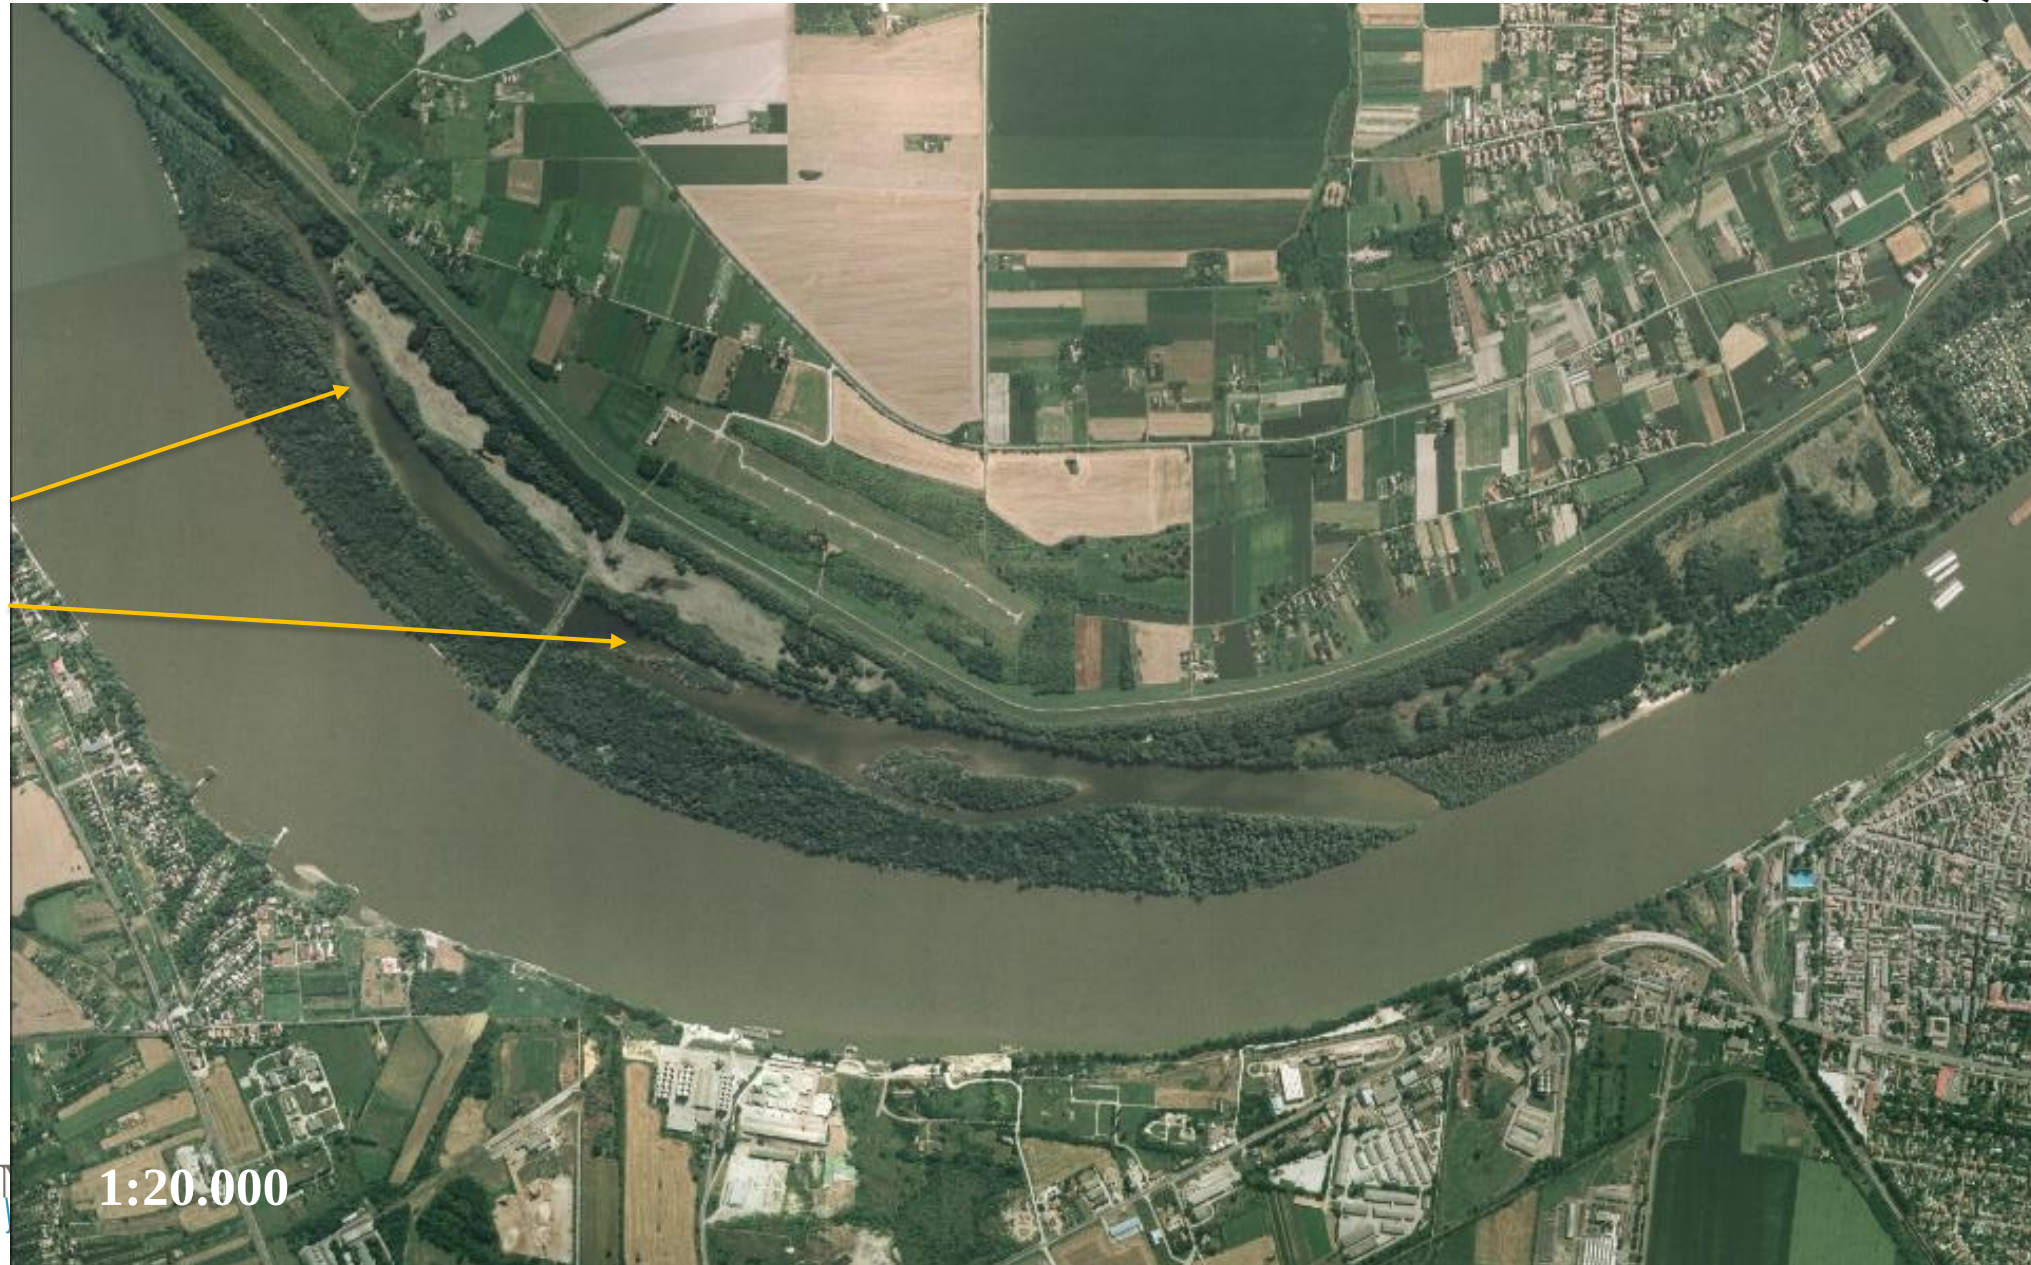
Ortophoto of the  
site, 2005

Heavy  
sedimentation,  
no living water
